NATIONAL RESEARCH COUNCIL
CANADA
DIVISION OF BUILDING RESEARCH

THE WHITEHORSE ESCARPMENT

R.F. Legget and G.H. Johnston

Report No. 136
of the
Division of Building Research

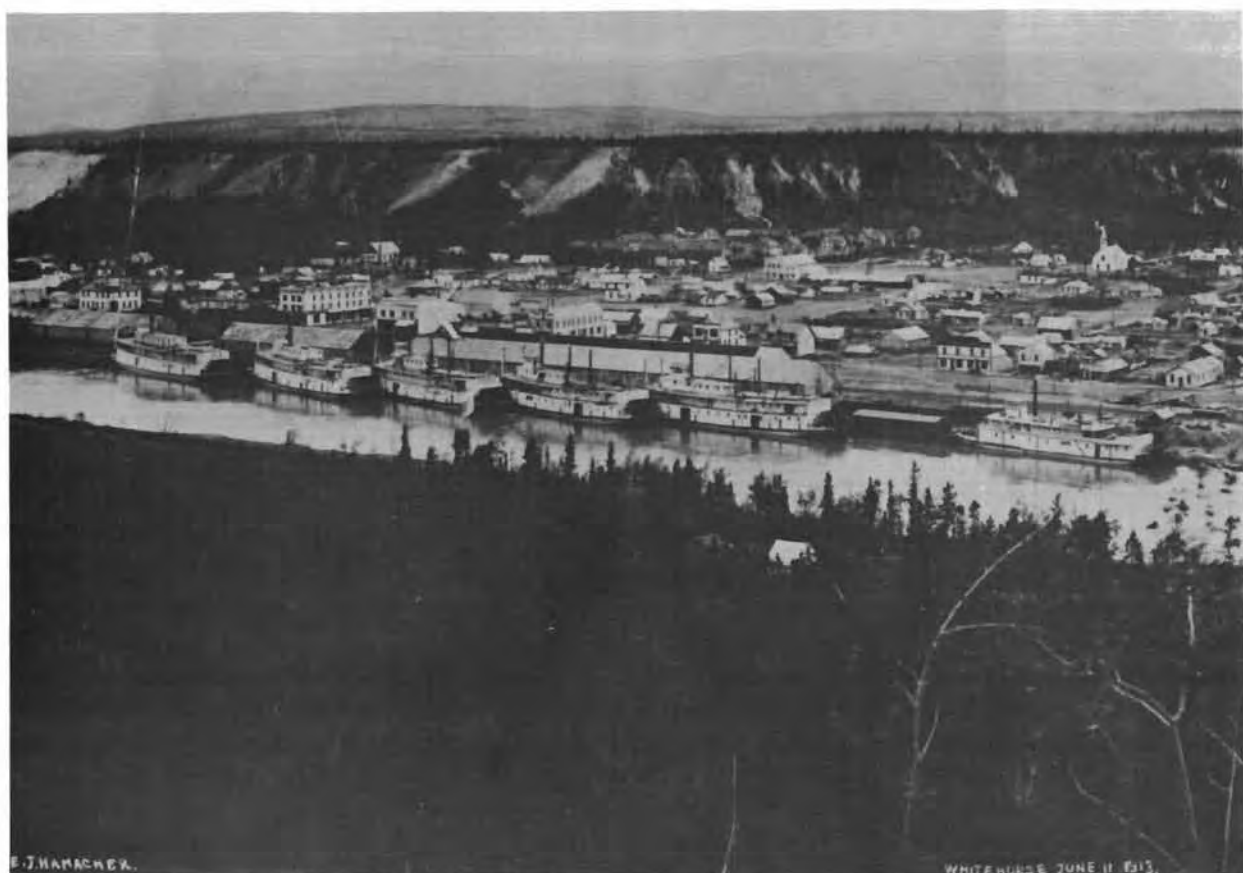
It can be seen from Fig. 1 (June 13, 1913) that those parts of the slope which then had no trees or standing vegetation had a surface cover of grass, which no doubt, is the same as the grass cover existing on similar slopes in the vicinity today. It will also be noted that what appear to be mud flows were even then taking place on the face of the escarpment but were minor and much less extensive compared to those occurring at the present time.

Figure 1. Whitehorse - June 11, 1913. Note "bridle path" on face of escarpment. (Photo taken by E. J. Hamacher; original print loaned by W. D. McBride, Whitehorse.)

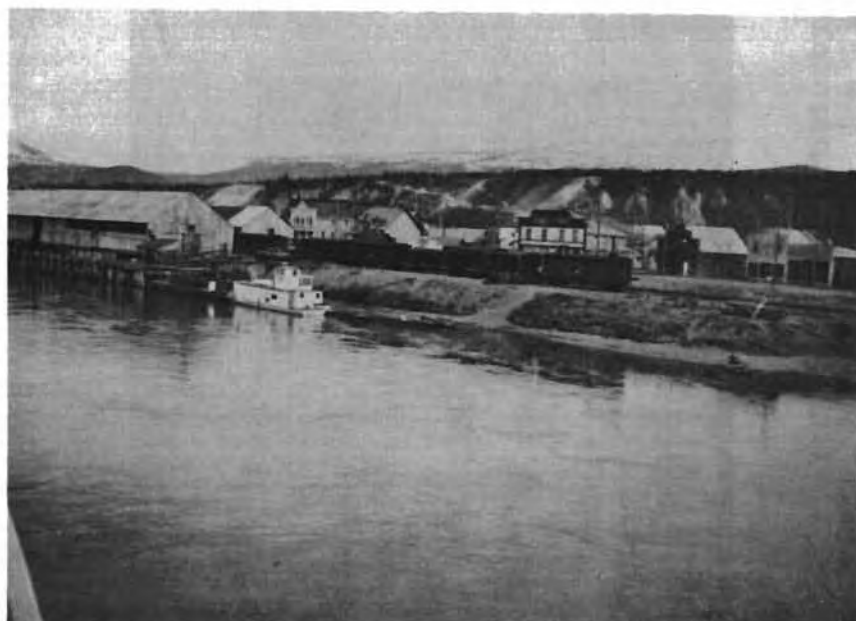
Figure 4. Town of Whitehorse and escarpment, 1938. (Note "bridle path" and Whitepass and Yukon route access road to airfield.) (Geol. Survey of Canada photo No. 84601)

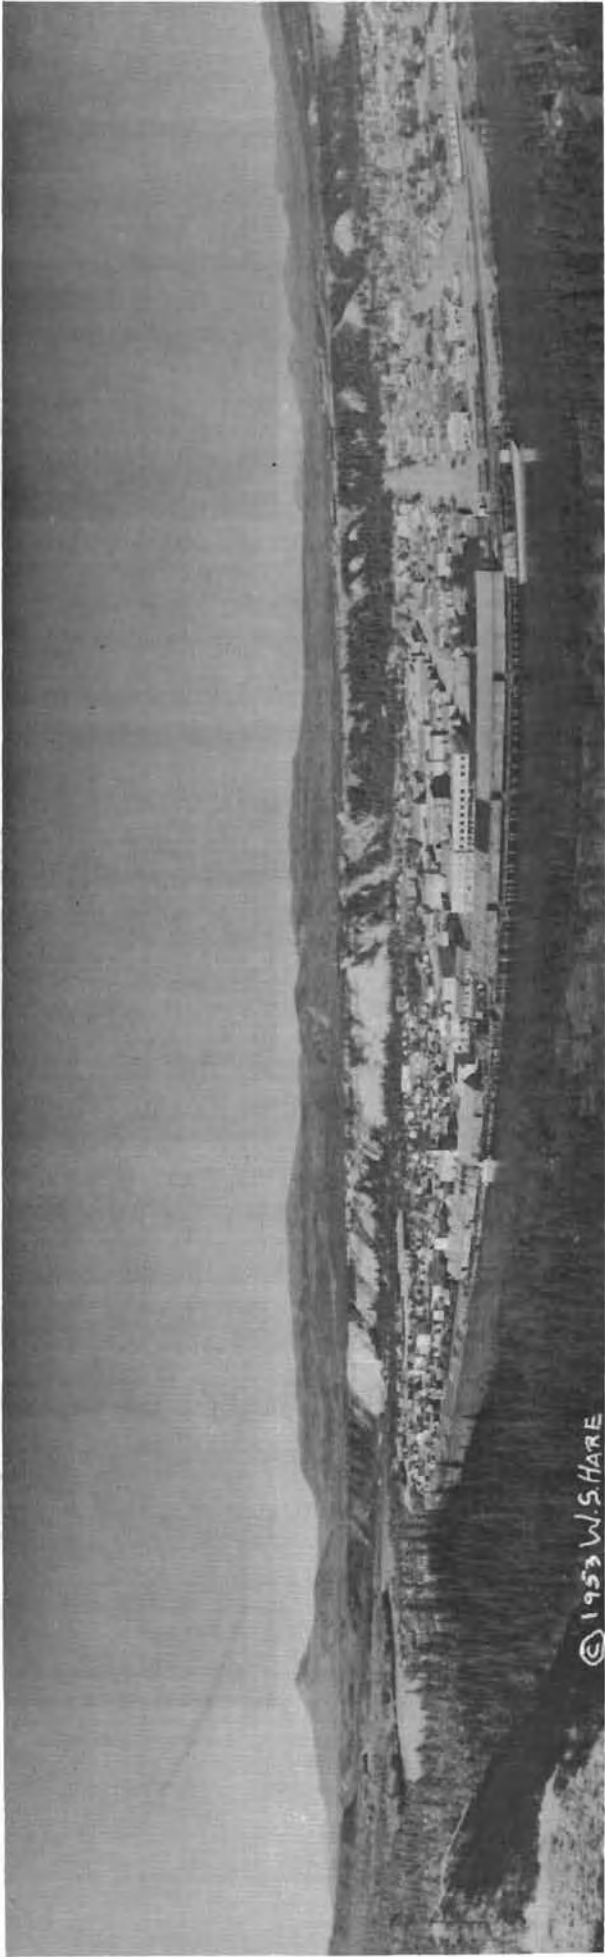
In contrast with what is shown on old photos (Figs. 1 and 4), which show the face of the escarpment in a relatively well-wooded condition, the vegetation today (Fig. 5) has been totally destroyed or at least badly disrupted on that portion from the southern extremity of the building area on the top of the escarpment to approximately a point in line with the cross runway or about 1,000 feet north of the northern limit of the building area. The total length of escarpment involved is about 4,000 feet.

Figure 5. Whitehorse, 1953 (Photo by
W.S. Hare)

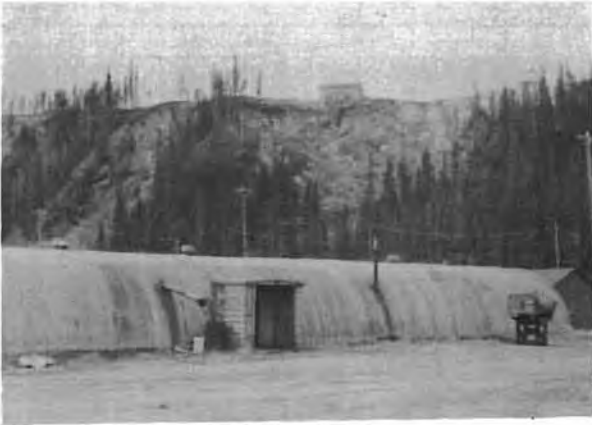
Figure 7. Sloughing on slope at DOT garage (at top of bank), May 1957 (DBR photo BR 6763)

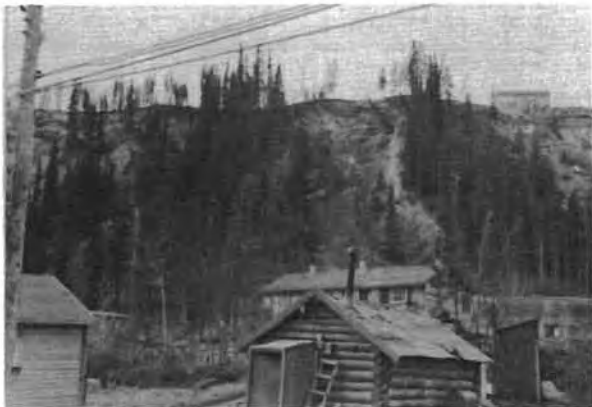
Figure 8. Sloughing near DOT garage, May 1957. (DBR photo BR 6764)

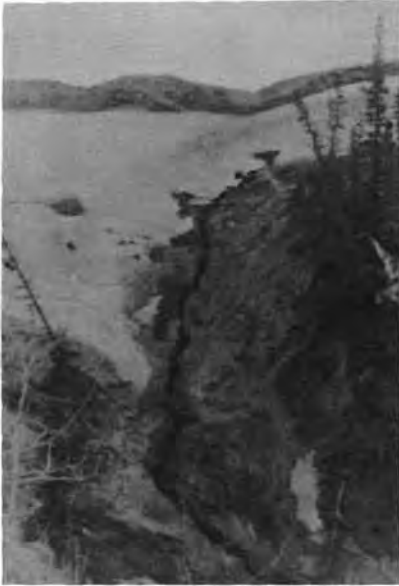
Surface run-off from the airfield had caused gullying in two places adjacent to the east end of the cross runway (one being opposite the culvert through the road to the west side of the field). Both had dried up but had evidently carried a good deal

Figure 9. Snow drift on scalloped area east of cross runway. Gully caused by surface runoff from airfield can be seen at edge of slope in line with gullying on face, May 1957 (DBR photo BR 6765)

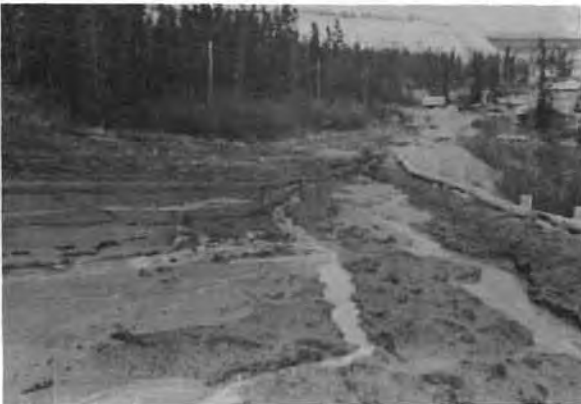
Figure 10. "Mud" streams flowing down lower sections of abandoned access road, May 1957 (DBR photo BR 6766)

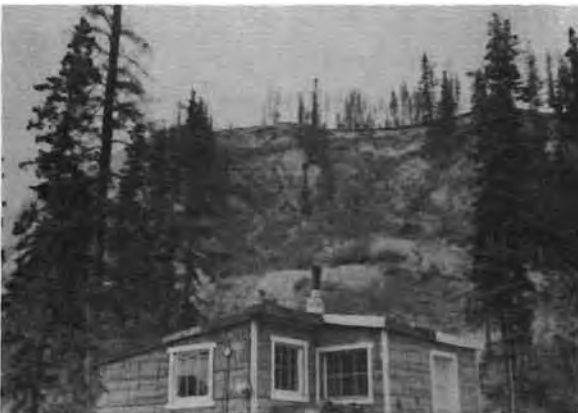
Figure 11. Erosion of bank behind DOT residences (at top of slope), May 1957 (DBR photo BR 6767)

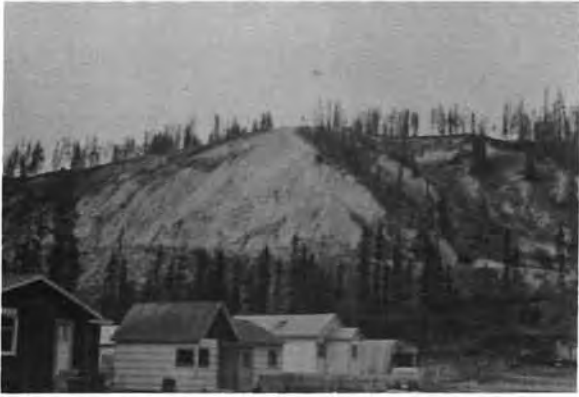
Figure 12. Dry face of escarpment immediately behind DOT residences (at top of slope), May 1957 (DBR photo 6768)

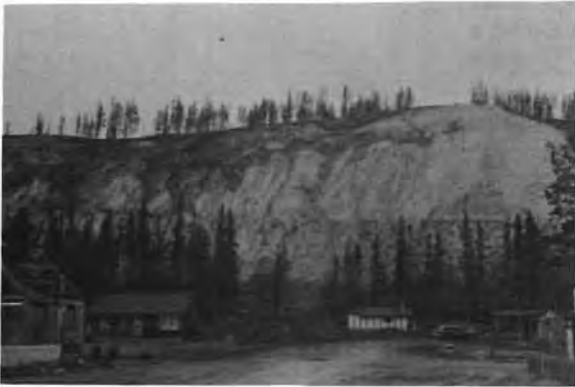
Figure 13. Another view of dry face of escarpment, May 1957 (DBR photo 6769)

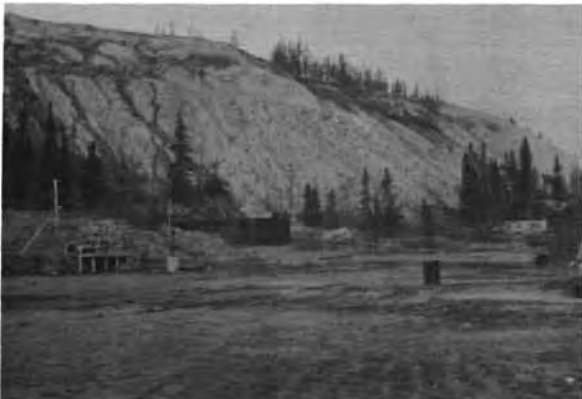
Figure 14. "Mud" runs flowing around oil storage tanks and down into town over railway Y tracks, May 1957 (DBR photo BR 6770)

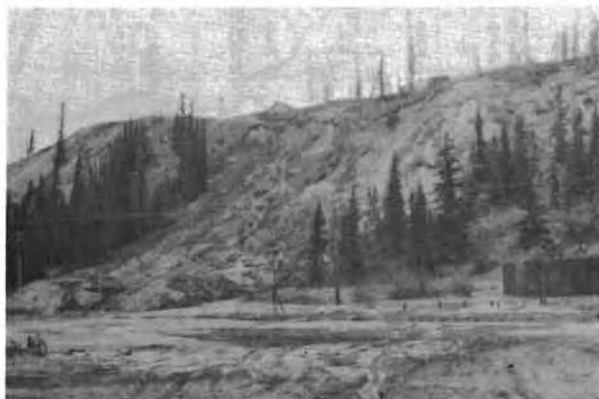
Figure 15. Extensive sloughing on slope has completely obliterated access road at its upper end, May 1957 (DBR photo BR 6771)

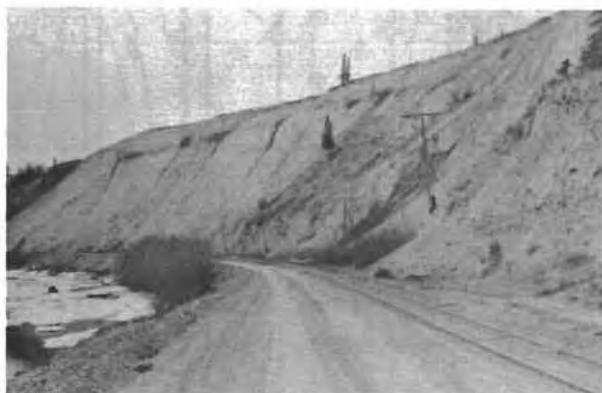
Figure 16. Steep, dry slope adjacent to railway south of Whitehorse, May 1957. Note occurrence of some gullying on face and also soil stratification on right side of photo (DBR photo BR 6772)

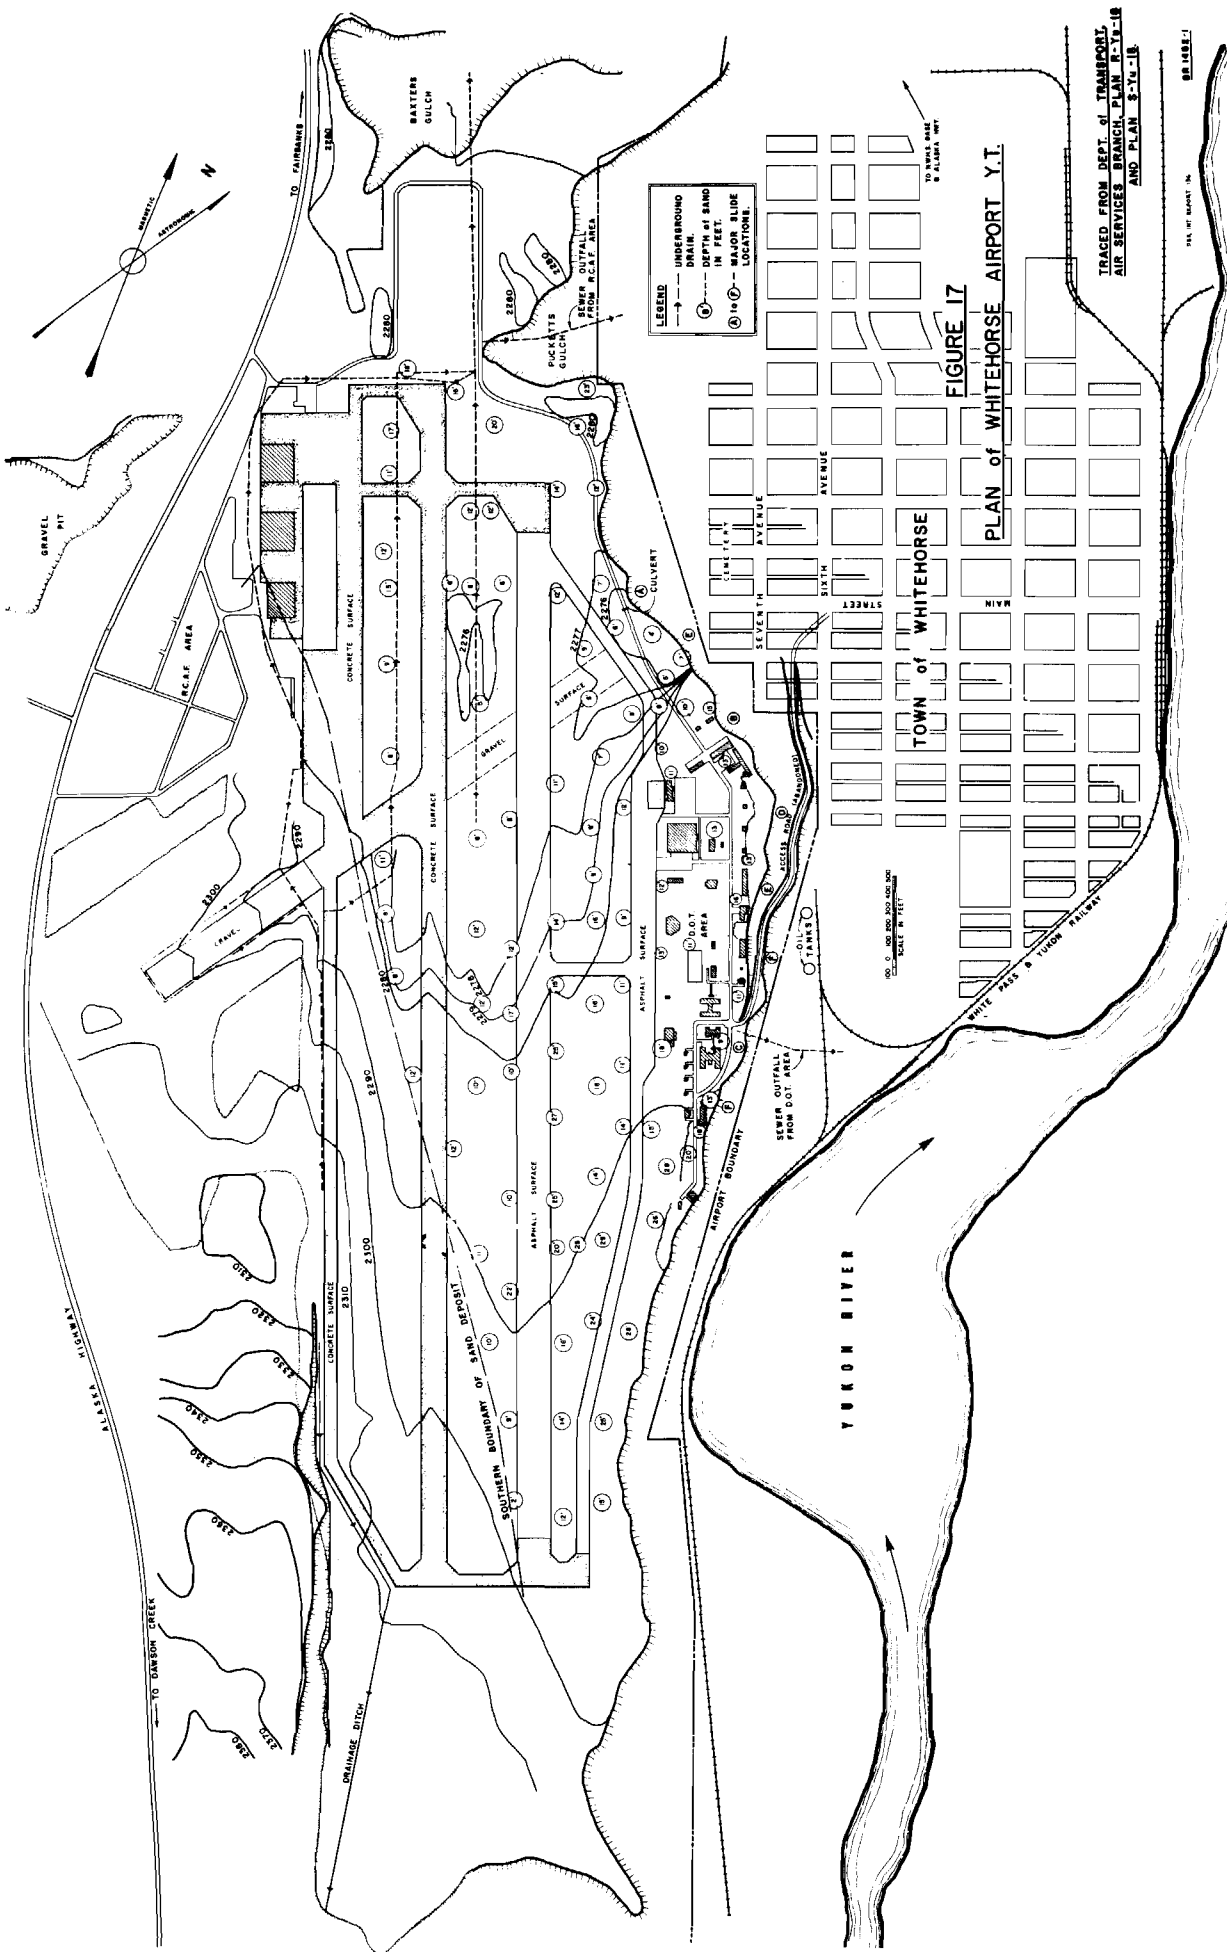
In 1950, further sliding of the slope around the outfall sewer necessitated cribbing and backfilling to prevent freezing and further damage to the line. The occurrence of more slides (D, Fig. 17) along the escarpment was endangering several dwellings in the Town of Whitehorse at the base of the slope. A preliminary engineering investigation by D.O.T. engineers indicated the need for considerable study of the problem before remedial measures could be taken.

The most serious slides occurred (A and E, Fig. 17) in 1953 when large quantities of "soupy" material flowed down into the Town of Whitehorse causing considerable damage to private property. Light snowfall (and thus deep frost penetration) and excessive rainfall in the preceding winter and during the spring respectively were thought to have been a major contributing factor. Sloughing and mud flows, varying in degree of seriousness, have occurred each year since, on the face of the escarpment (F, Fig. 17).
