NATIONAL RESEARCH COUNCIL
CANADA
DIVISION OF BUILDING RESEARCH

THE WHITEHORSE ESCARPMENT

R.F. Legget and G.H. Johnston

Report No. 136
of the
Division of Building Research

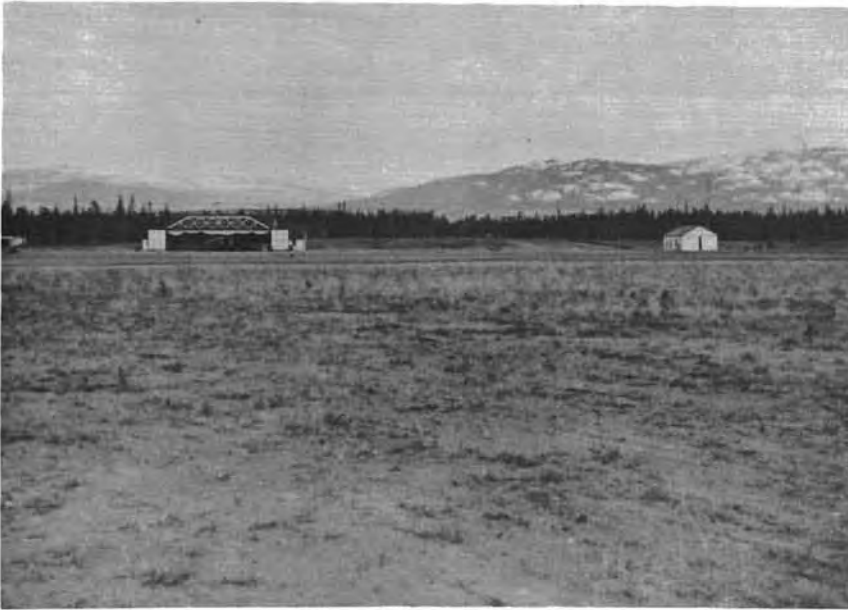
It was not until 1927, however, when the Yukon Airways and Exploration Co. Ltd. was incorporated, that commercial aviation got its start. Klondike Airways Ltd. began operations in 1928 initiating air mail service to Mayo. In 1929, it was announced by the Hon. Charles Stewart, Minister of the Interior, that ample land had been set aside (at Whitehorse) for aviation purposes. Some of the land required for the airfield was donated by the White Pass and Yukon Route. The sum of \$1,000 collected by subscription from local residents at this time was used to clear some brush and level off parts of the airstrip. Additional clearing, though not extensive, was carried out adjacent to the airstrip during 1930 to 1936. Some gravel (decomposed granite) obtained nearby was used to level off bumps and hollows on the grassy meadow (Figs. 2 and 3).

Figure 2. Whitehorse Airfield, 1939, looking east. (Geol. Survey of Canada photo No. 86836)

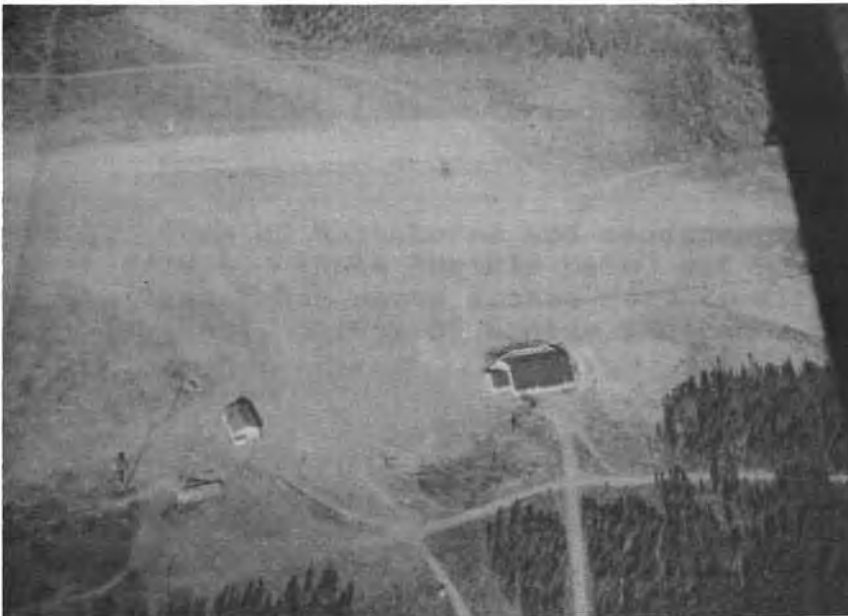
Figure 3. Vertical air view of Whitehorse Airfield, 1939, (north on right side of photo). (Geol. Survey of Canada photo No. 86838)

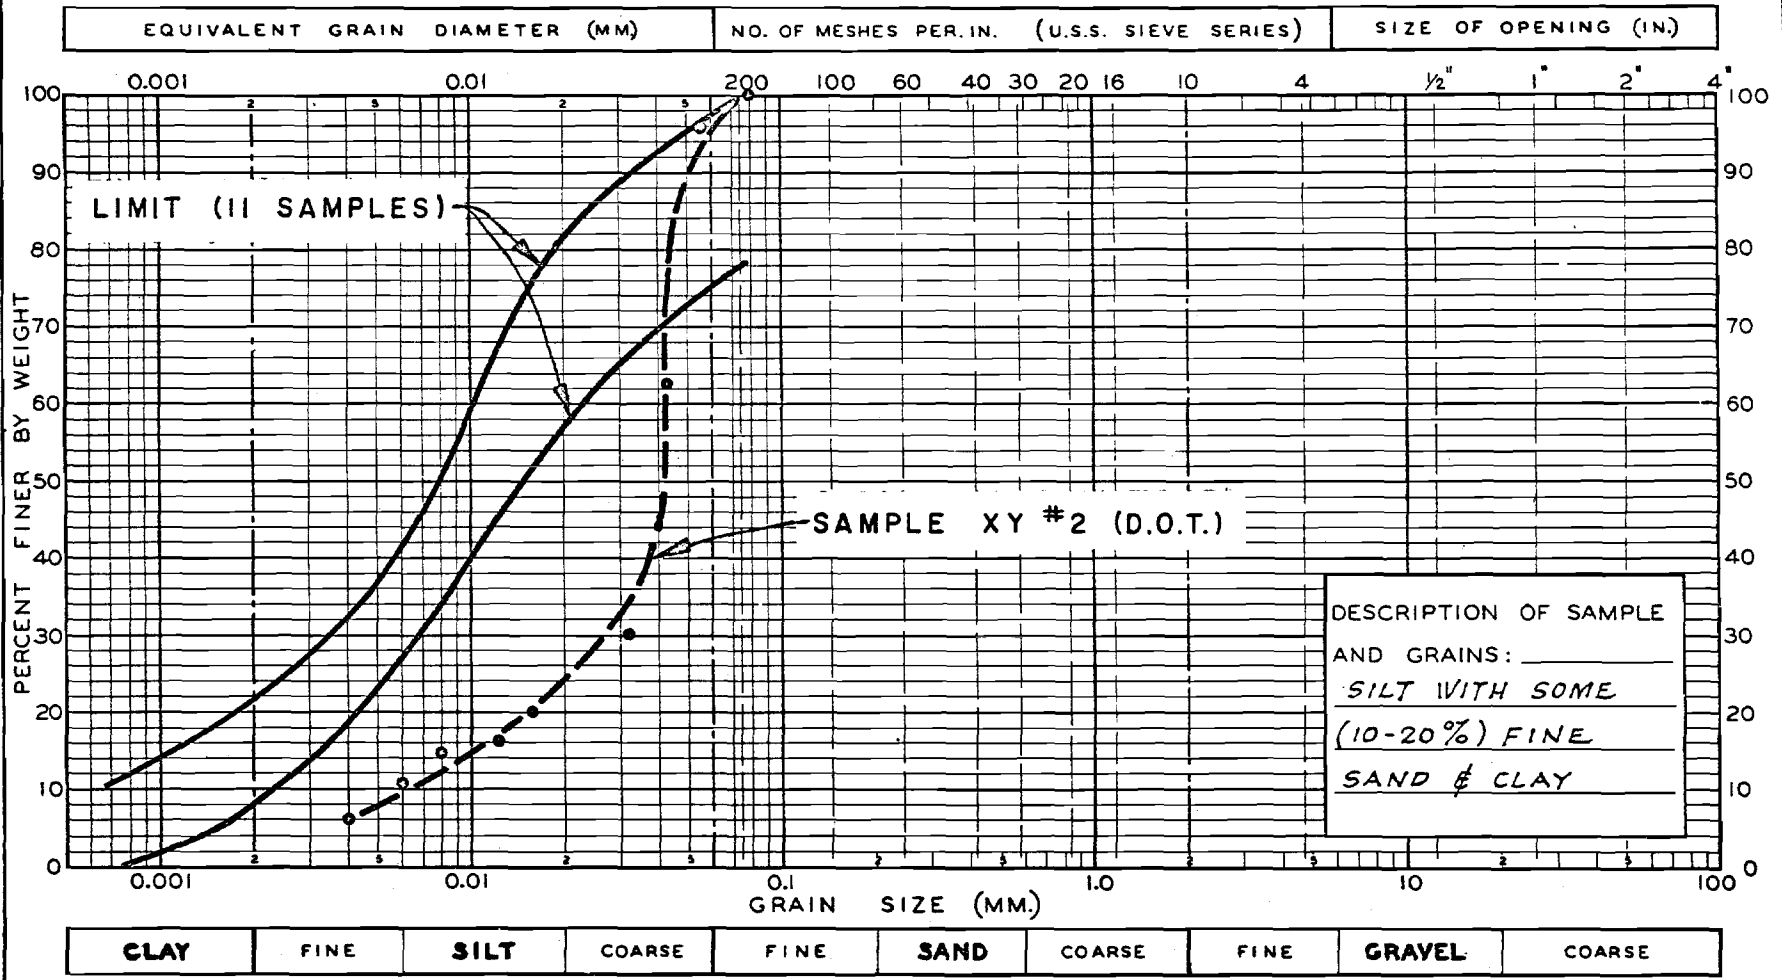
MECHANICAL ANALYSIS OF SOILS

DESCRIPTION OF SAMPLE AND GRAINS:
SILT WITH SOME (10-20%) FINE SAND & CLAY

WHITEHORSE SILT - GRAIN SIZE DISTRIBUTION LIMITS.
